RECORD OF INVESTIGATION INTO DEATH

Ref No: 30/12

*I, Alastair Neil Hope, State Coroner, having investigated the death of **Tharmeswaran THAMBIAIYA**, with an Inquest held at Perth Coroners Court on 14 September 2012 and 22 October 2012 to 24 October 2012 find that the identity of the deceased person was **Tharmeswaran THAMBIAIYA** and that death occurred on or about 1 November 2009 in the Indian Ocean and was Consistent with Immersion (Drowning) in the following circumstances -*

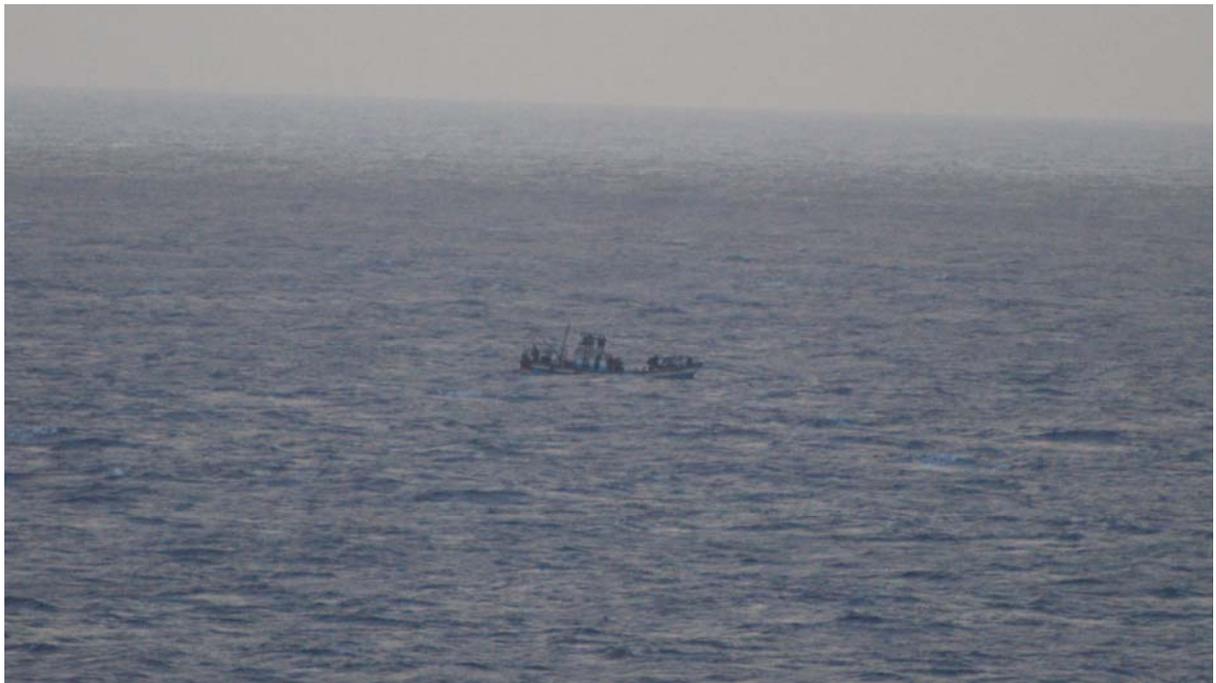
The above photograph taken from the MV LNG Pioneer shows SIEV 69 at about the time FV Kuang Win left the area

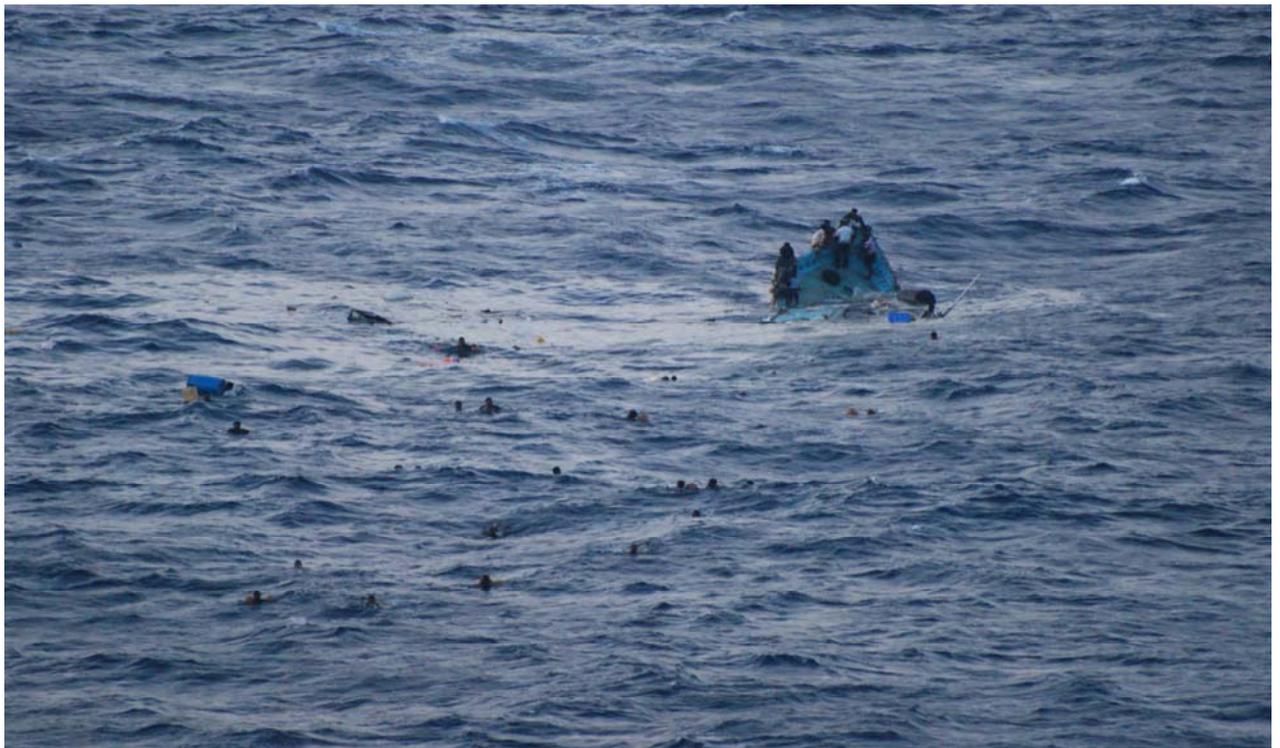
The above photograph taken from the MV LNG Pioneer shows people in the sea shortly after SIEV 69 sank
